# Manhole Inspection Summary

Manhole # S39Y1\_012MH

**Location** Address: **408 Cambria Street**

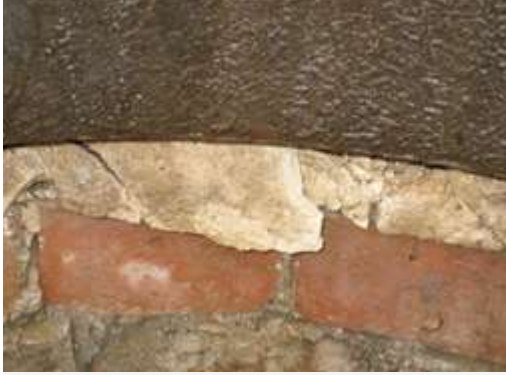
Defect 4

Condition: ☐ Sound ☒ **Cracked** ☐ Root Intrusion ☒ **Loose Brick** ☐ Deteriorated

loose bricks on chimney

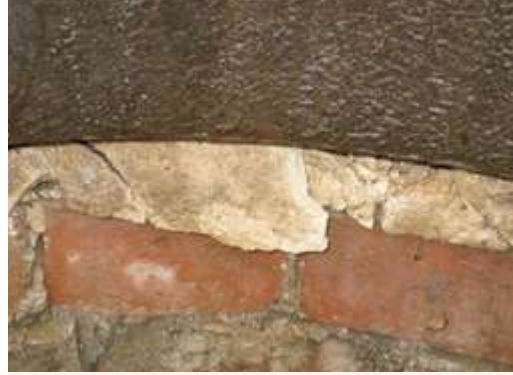
Defect 2

loose bricks on chimney

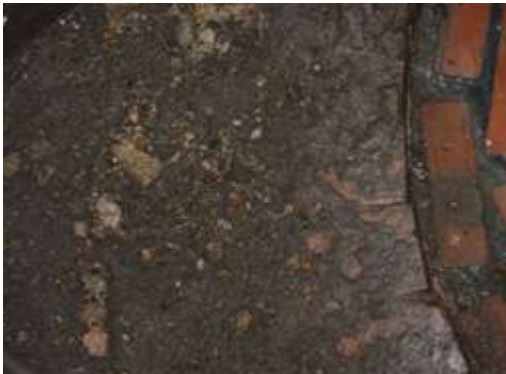
Defect 1

debris

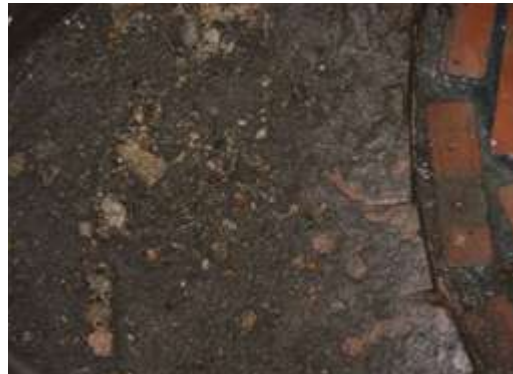
Defect 3

debris

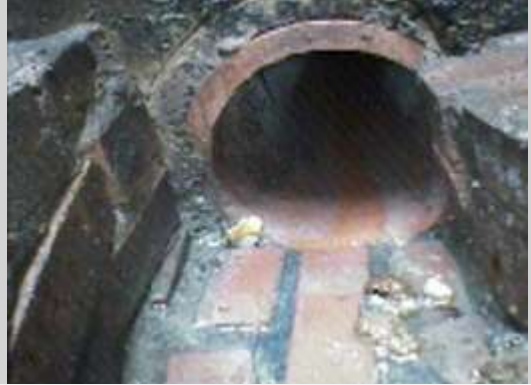
12 O'Clock Outflow

8 in. Circular Gravity Sewer  
Pipe Out @ 12 O'Clock

Pipe Height: **8.4** (in.) Rod and Bar (Angled)  
Pipe Material: **Clay** ☐ Pipe Lined  
Invert Depth: **6.30** (ft.) Flow Characteristics: **Slow**  
Deposits: ☒ None ☐ Mud ☐ Sludge ☐ Debris ☐ Grease  
Silt Depth: (in.) Deposits Extent:  
Infiltration: **None** Pipe Seal Cond: **Sound**

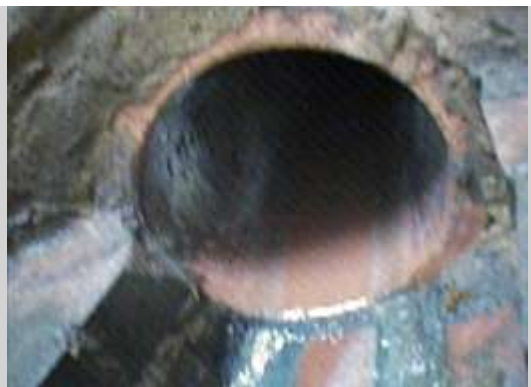
3 O'Clock Inflow

8 in. Circular Gravity Sewer  
Pipe In @ 3 O'Clock

Pipe Height: **7.2** (in.) Rod and Bar (Angled)  
Pipe Material: **Clay** ☐ Pipe Lined  
Invert Depth: **5.60** (ft.) Flow Characteristics: **Slow**  
Deposits: ☒ None ☐ Mud ☐ Sludge ☐ Debris ☐ Grease  
Silt Depth: (in.) Deposits Extent:  
Infiltration: **None** Pipe Seal Cond: **Sound**
